Technical Report CERC-96-8
September 1996

Periodic Inspection of Burns Harbor North Breakwater, Indiana

Report 1 Base Conditions

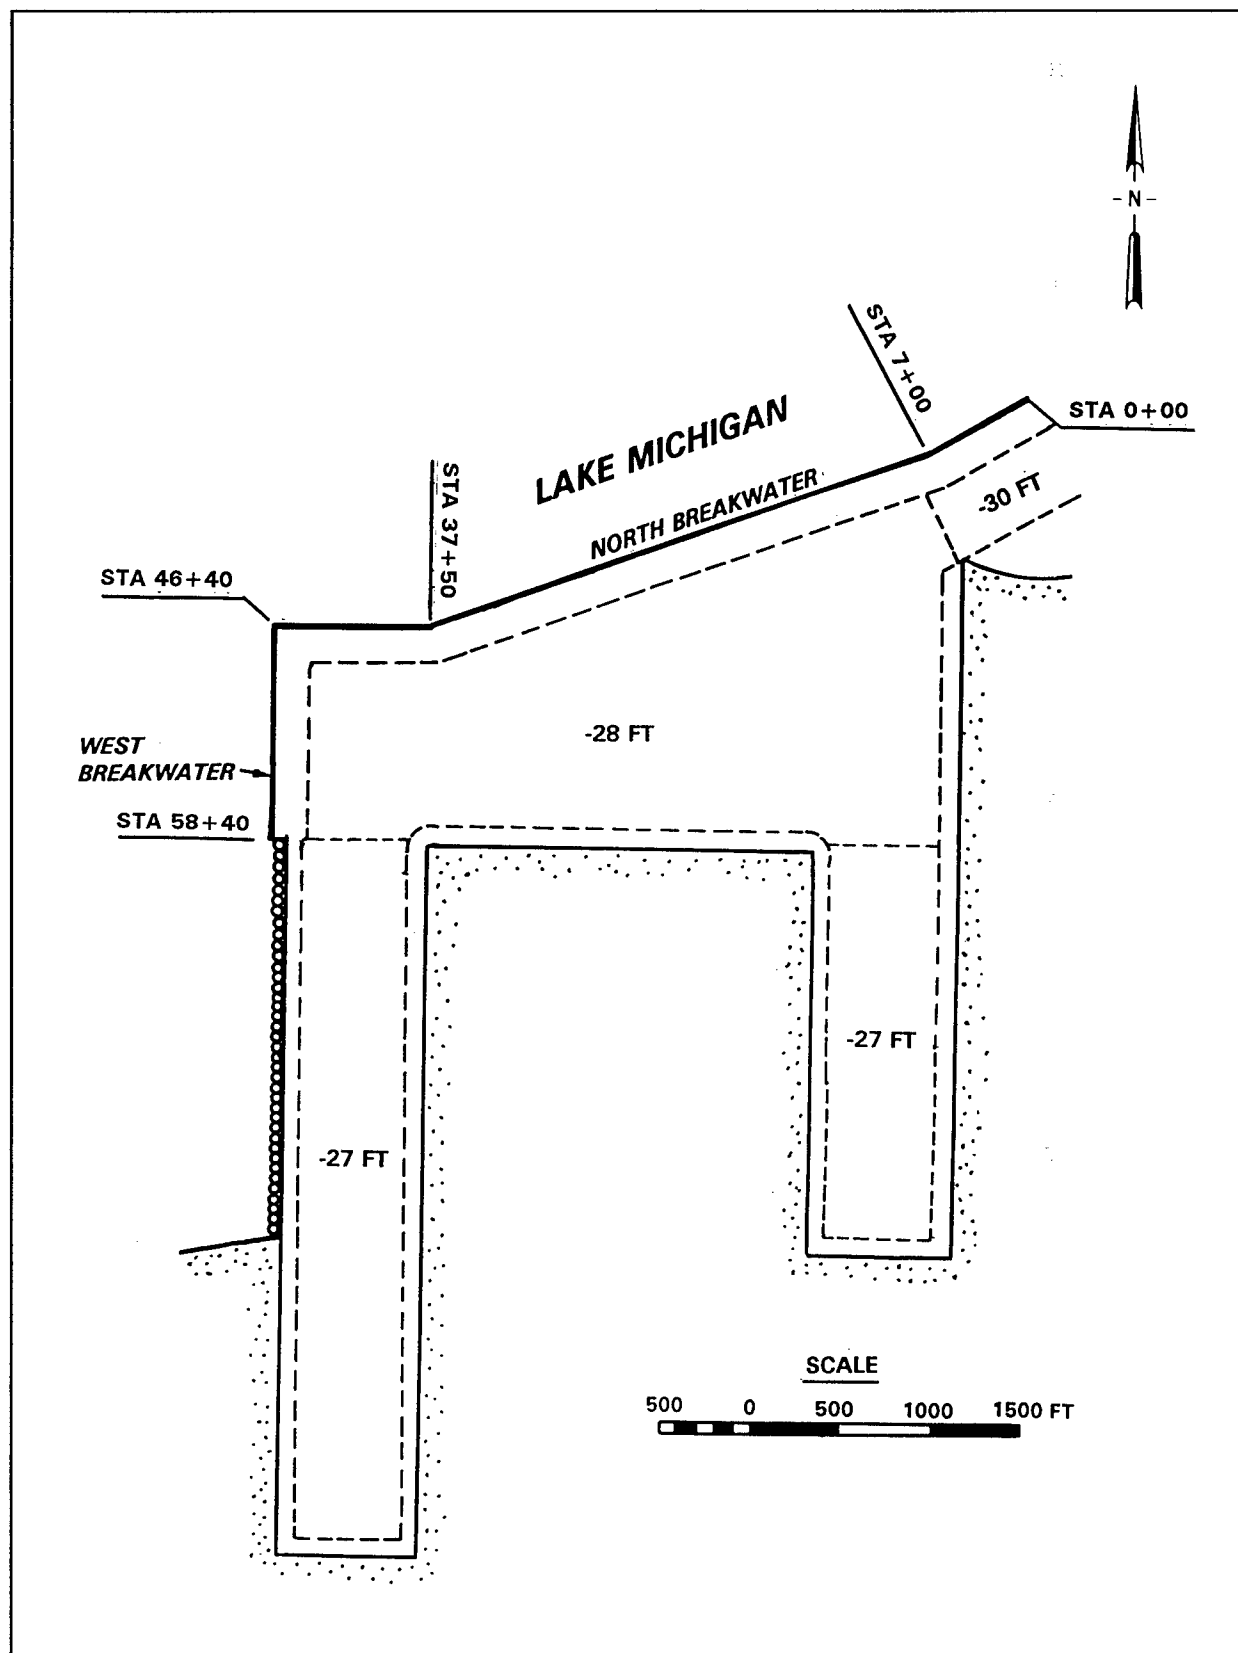
Figure 2. Layout of Burns Harbor, Indiana

The harbor project (Figure 2) consists of north and west breakwaters with an aggregate length of 1,780 m (5,840 ft), a 122-m-wide, 9.1-m-deep² (400-ft-wide, 30-ft-deep) approach channel, an 8.5-m-deep (28-ft-deep) outer harbor area, a 670-m-long, 189-m-wide, 8.2-m-deep (2,200-ft-long, 620-ft-wide, 27-ft-deep) east basin, and a 1,173-m-long, 189-m-wide, 8.2-m-deep (3,850-ft-long, 620-ft-wide, 27-ft-deep) west basin.

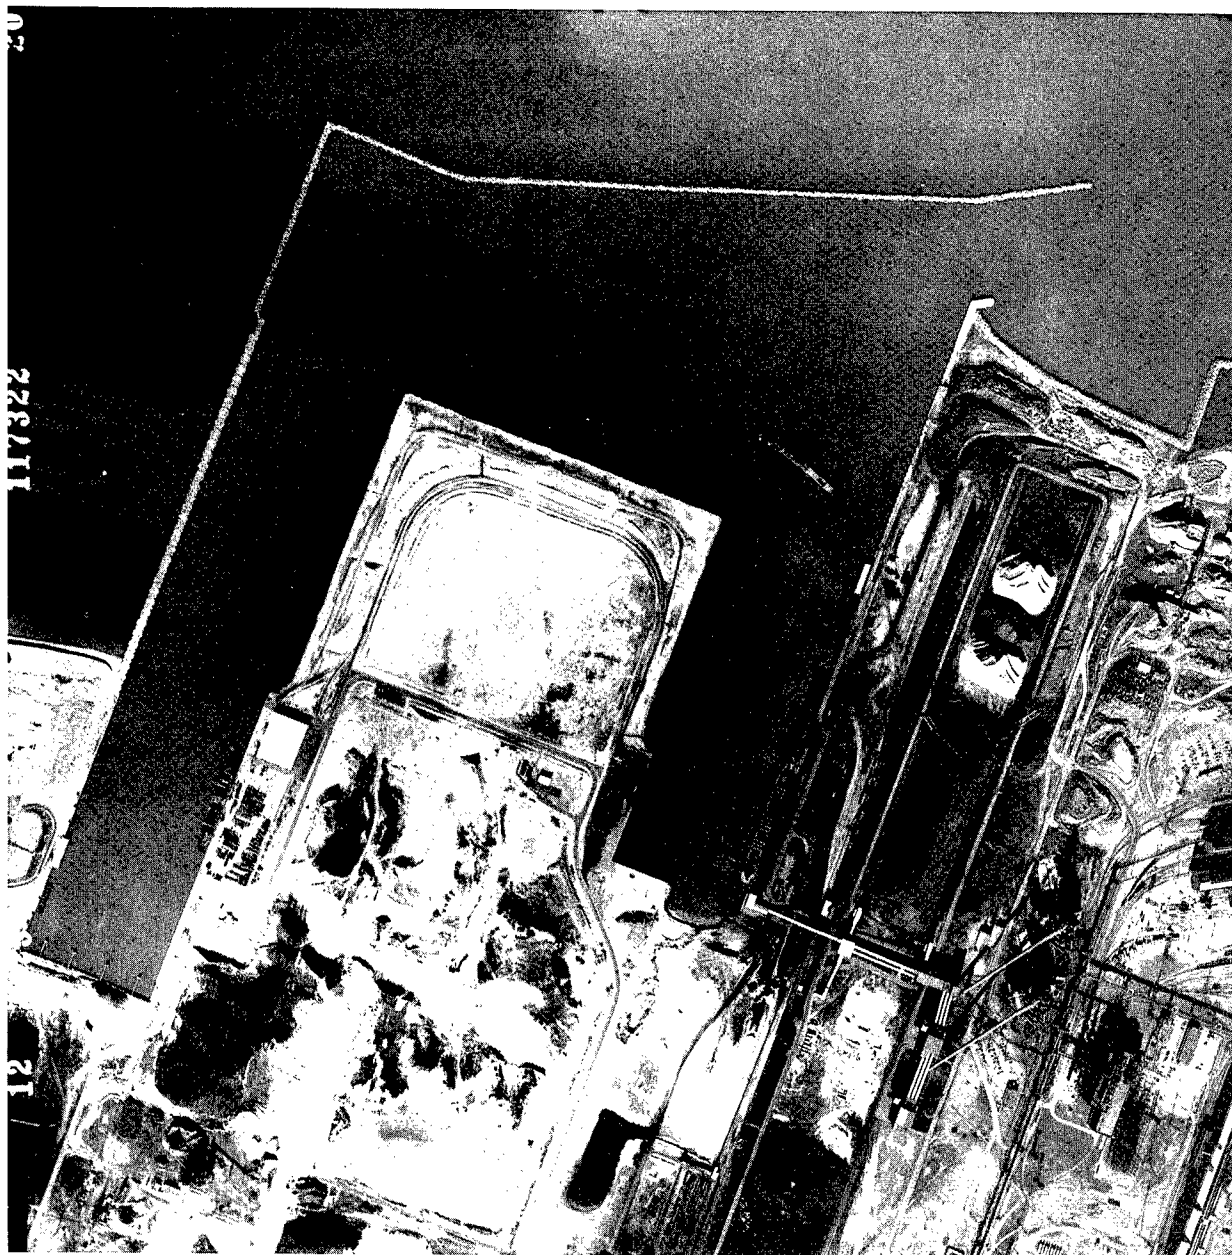
Figure 3. Aerial view of Burns Harbor

cellular steel sheet-pile extension connecting the west breakwater to shore. An aerial photograph of the harbor is shown in Figure 3.

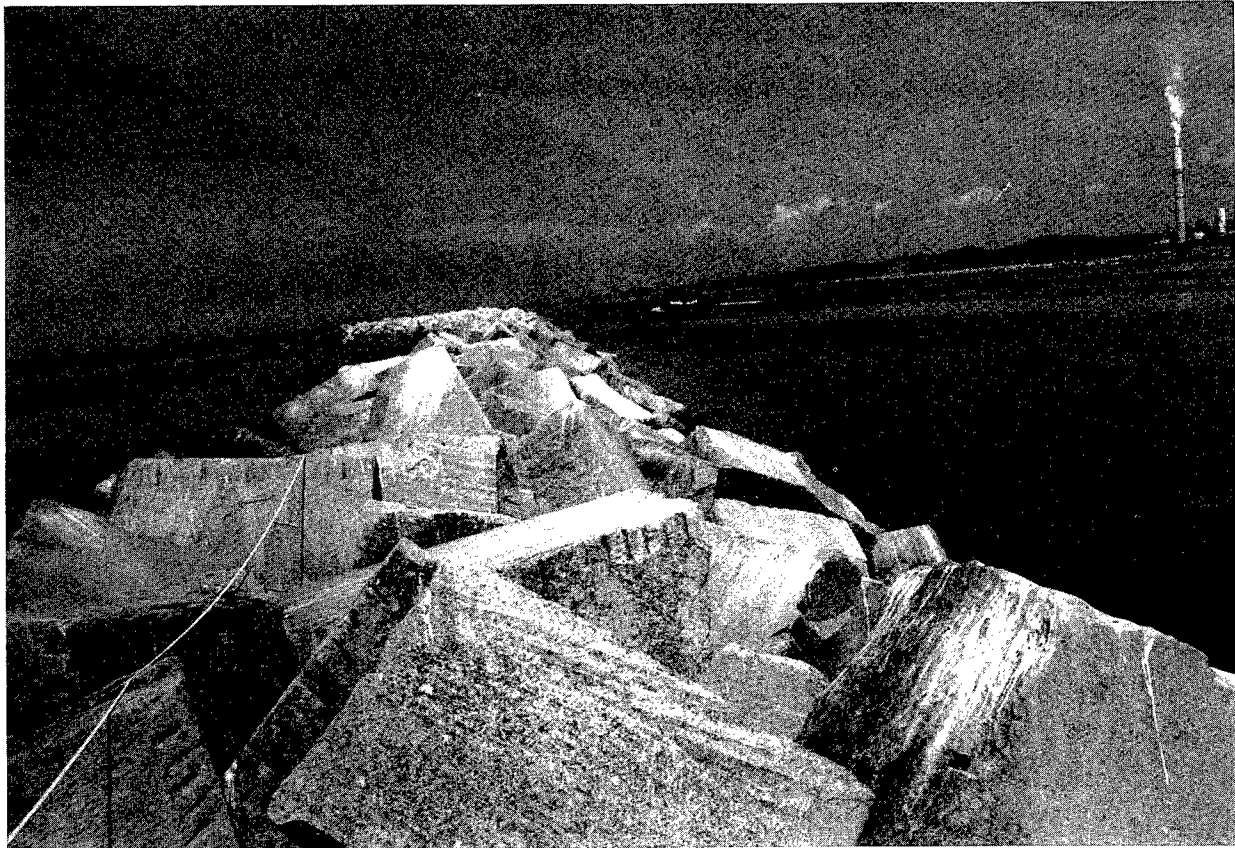
Figure 4. View of armor stone on breakwater trunk

The rubble-mound breakwater was constructed with a multi-layered design and random placement of the armor stone cover layers. The crest elevation of the structure was +4.3 (+14) and the toe elevation was approximately -12.2 (-40). Armor stones consisted of rectangular cut Indiana Bedford limestone blocks ranging from 9,100 to 13,600 kg (10 to 15 tons) on the trunk (Figure 4) and 13,600 to 18,100 kg (15 to 20 tons) on the head. A cross section of the original breakwater is shown in Figure 5.

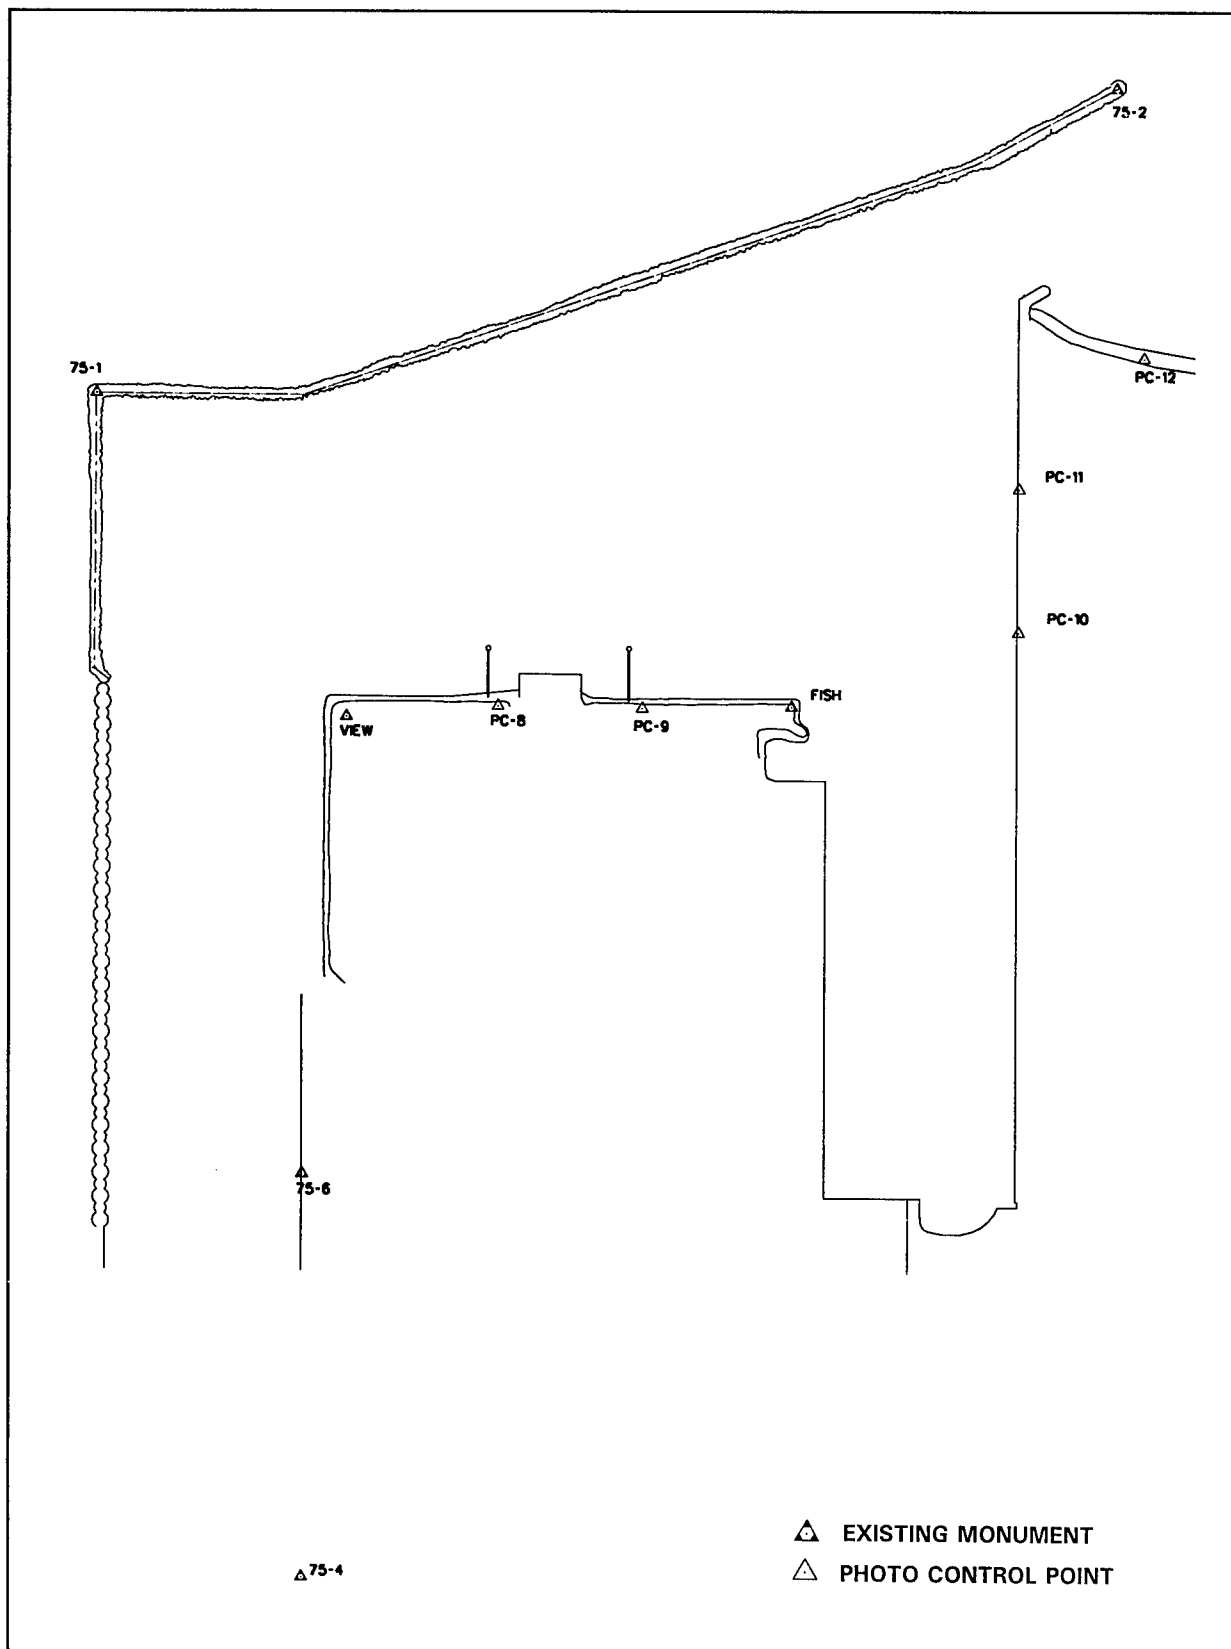
Figure 6. Locations of existing monuments and photo control points

Existing monuments in the vicinity of the harbor were used to serve as reference points (both horizontal and vertical reference) for the ground-based survey work as well as photogrammetric work. Ground surveys were initiated from these monuments. In addition, photo control points were established using global positioning system (GPS) control surveying and electronic land surveying techniques. The existing monuments were bronze disks, cemented into place, and photo control points were established with steel rods. Locations of the existing monuments and the photo control points are shown in Figure 6. Positions and elevations of the monuments and photo control points are listed in the following tabulation:

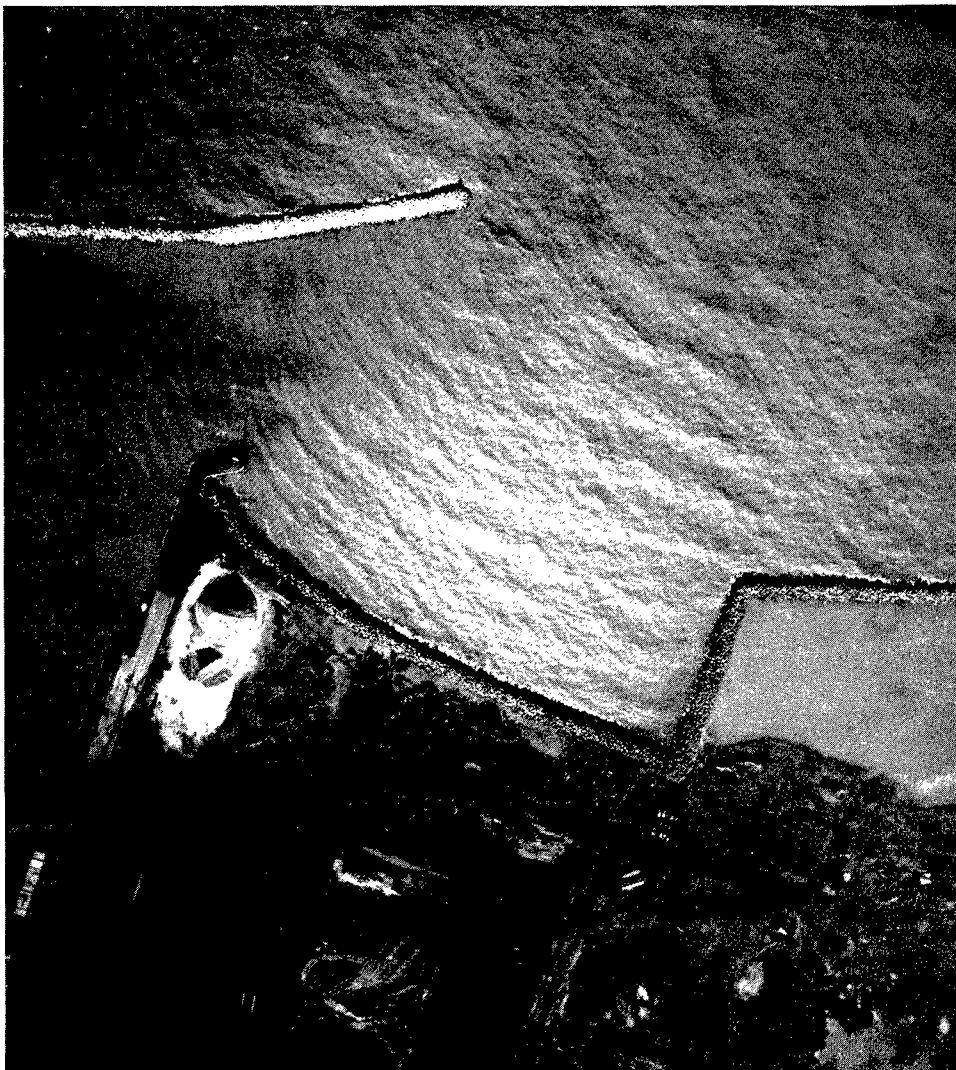
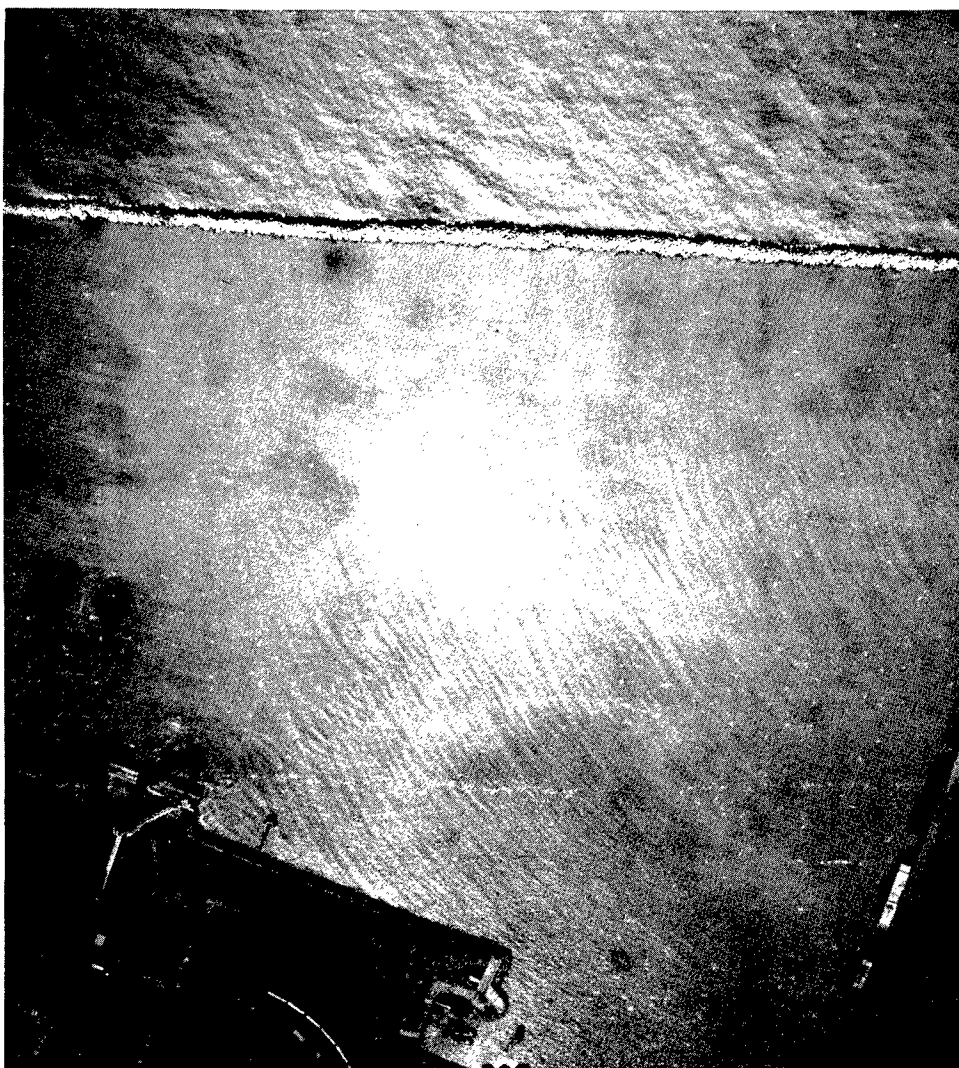
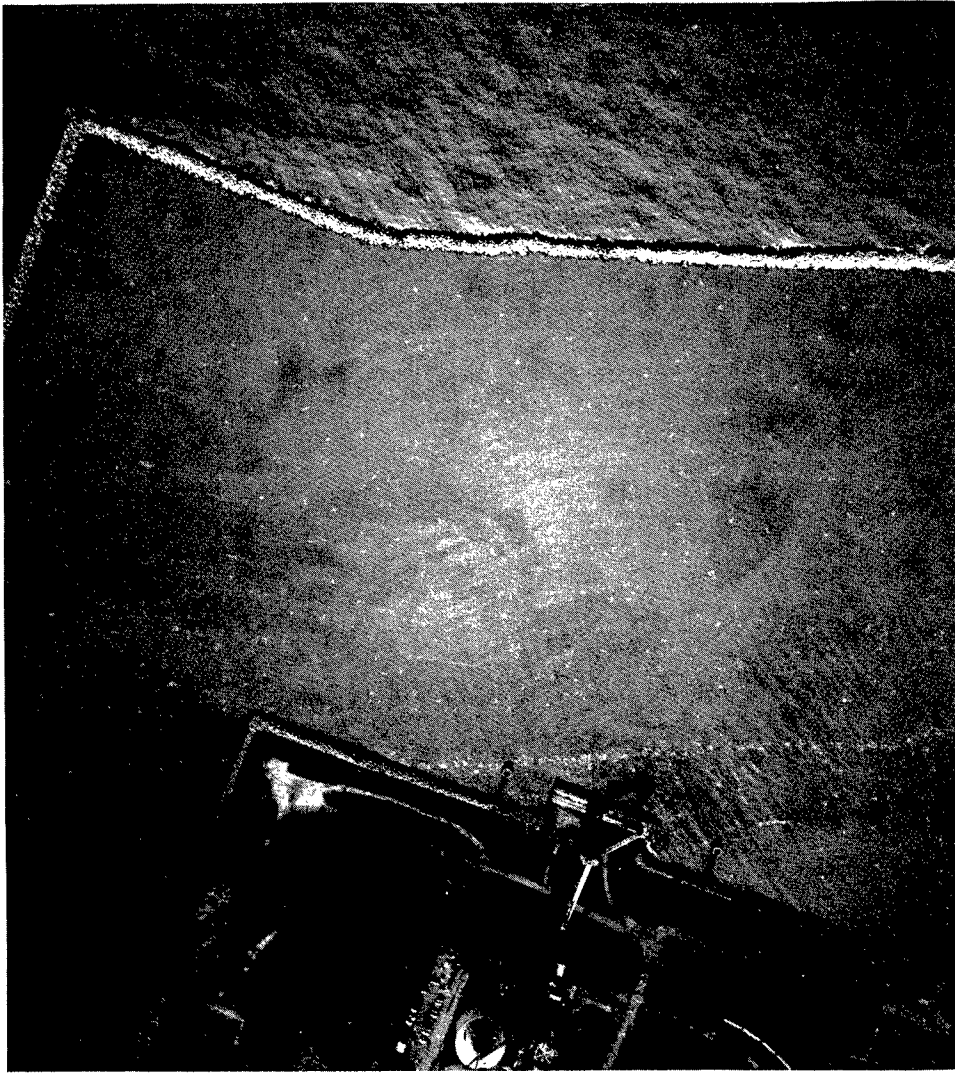
Figure 7. Stereo pair photographs for Burns Harbor North Breakwater
(Sheet 1 of 5)

Aerial photography was obtained along the breakwater with a Zeiss RMKA 15/23 aerial mapping camera (228-mm by 228-mm (9-in. by 9-in.) format). Color photos were secured from a fixed-wing aircraft flying at an altitude of 549 m (1,800 ft), which resulted in high-resolution images and contact prints with scales of 1:3,600. Photographic stereo pairs were obtained during the flights. Stereo pairs secured for the breakwater are shown in Figure 7. The aerial photography was obtained on 10 November 1994. The lake level during the photography was +0.7 m (+2.3 ft) lwd.

The stereo pair images obtained during aerial photography at Burns Harbor were viewed in a Galileo Digicart Model 40 Analytical Stereoplotter, and stereomodels were oriented to the monument data previously obtained. In the stereomodel, very accurate horizontal and vertical measurements can be made of any point on any armor unit appearing in the print. The accuracy of photogrammetric spot elevations are on the order of ± 0.06 m (± 0.2 ft). The stereomodel was used for all photogrammetric compilation and development of orthophotography.

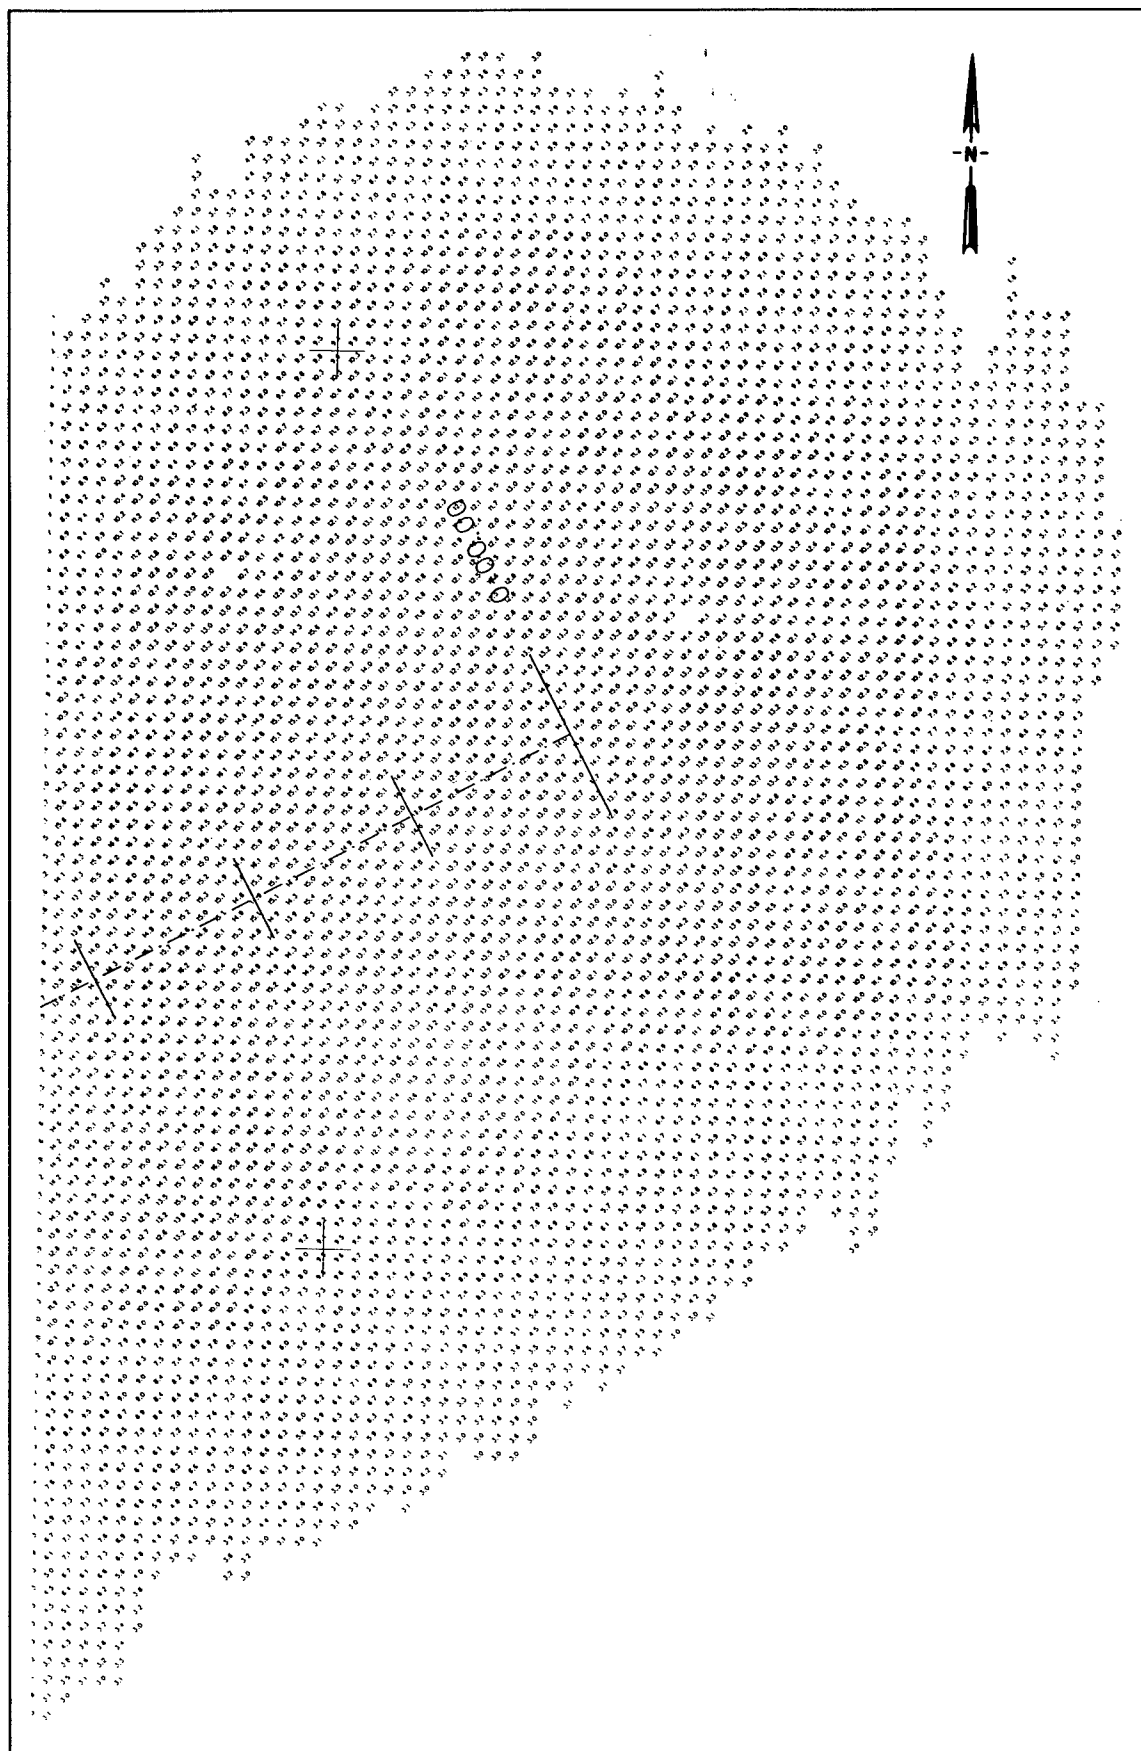
Figure 9. Point plot map for a portion of the North Breakwater

In addition to digital orthophotos, point plot maps, contour maps, and cross sections were developed for the North Breakwater using a digital terrain model (DTM). Point plot maps consisted of an approximately 0.3-m (1-ft) grid pattern overlaid on the structure. Precise vertical and horizontal measurements were obtained at the intersections of the grid. An example of a point plot map showing elevations on the breakwater is shown in Figure 9. Areas where no elevations are shown are shadowed areas, or voids between the armor units. Contour maps of the breakwater, developed from the DTM, for a 0.3-m (1-ft) contour interval are shown in Appendix A. In addition, using the analytical stereoplotter and DTM grid, cross sections of the breakwater were developed along the trunk of the breakwater at 15.2-m (50-ft) intervals and around the head of the structure at 0.26-rad (15-deg) intervals as shown in Figure 10. These cross sections are presented in Appendix B.

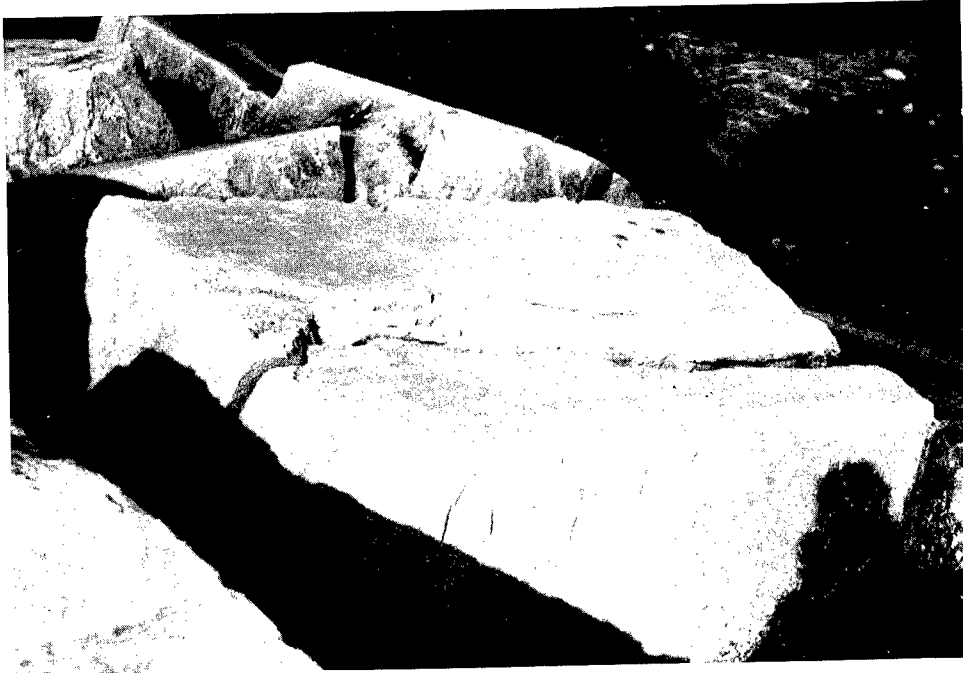
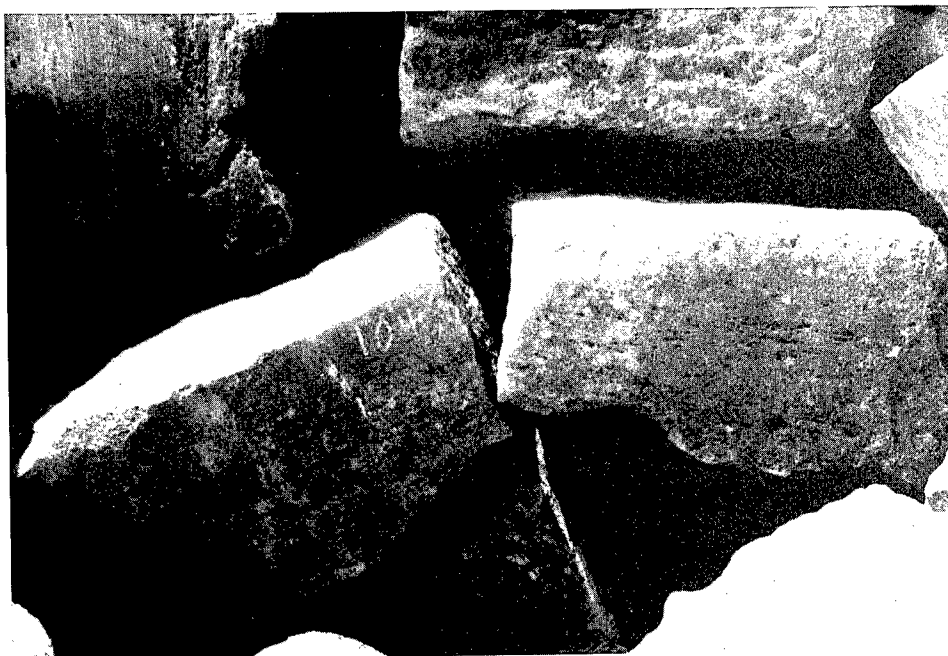
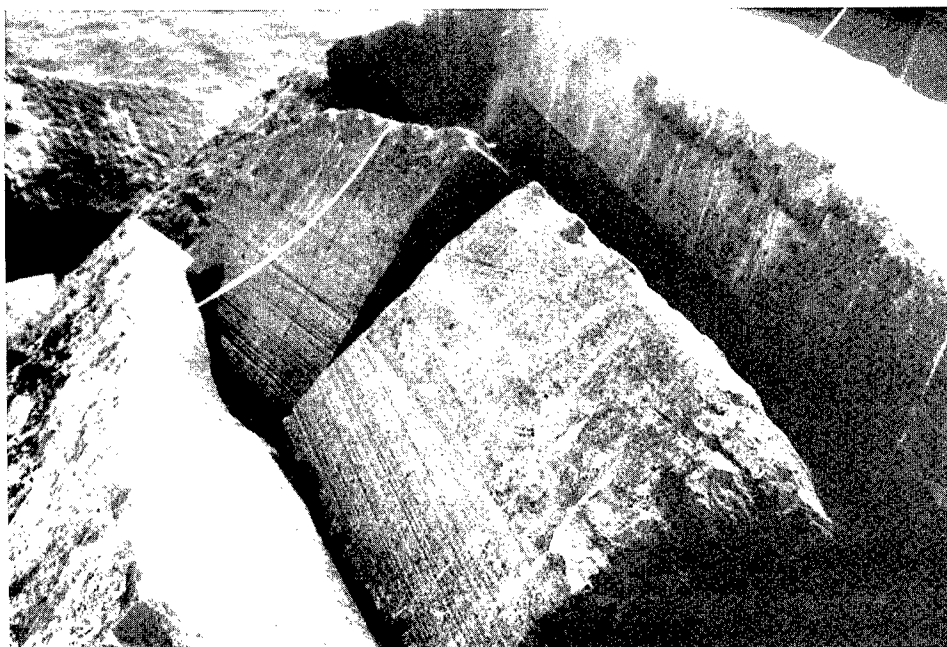
Figure 12. View of broken armor stone on North Breakwater (Continued)

During the period 25-26 July 1995, a survey of broken/cracked armor stone above the waterline on the 1,414-m- (4,640-ft-) long Burns Harbor North Breakwater was conducted. During the inspection, each broken armor stone was identified and photographed, and its approximate location relative to breakwater station and distance from a baseline was recorded. The baseline was the approximate center line of the structure. Armor stones with hairline cracks were not counted, only those that were cracked all the way through. Views of representative types of breaks are shown in Figure 12. The water was relatively clear during the survey, and the lake level was +0.6 m (+2.0 ft) lwd. The data recorded during the broken armor stone inventory are listed in Table 1.

The survey revealed a total of 165 broken or cracked armor stones above the waterline. Of the 165 stones, 26 were located along the breakwater crest, 95 on the lakeside slope, and 44 on the harbor side slope. No broken armor stones were observed around the head of the structure. The distribution of broken armor stones along the breakwater trunk as a function of station number and offset from the baseline is shown in Figure 13. As shown, broken stones occurred along the entire North Breakwater trunk, but in general, high concentrations were found along the easternmost portion of the structure. About 50 percent of the broken units (82 units) were located on the eastern one third (457 m (1,500 ft)) of the structure. The distribution of broken/cracked armor stones relative to offset from the baseline is shown in Figure 14. The majority of the broken armor stones along the structure (57 percent) were located on the lakeward face of the structure in the active wave zone. About 16 percent of the broken armor units were on the crest of the breakwater and 27 percent were on the harbor side of the structure. Detailed data obtained during the survey will allow for an accurate indication of new breaks when the structure is revisited at some point in the future.
